# KENWOOD

ASB-1032

## Service Bulletin

**Subject:** TS-450/690S Low Mic Gain w/DSP-100

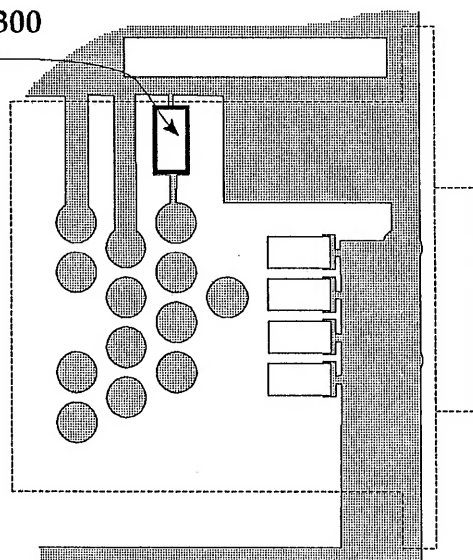
IF Unit (X48-3090-XX)  
Foil Side View

Proper microphone gain/ALC readings cannot be obtained unless the user adjusts the TX GAIN potentiometer on the rear of the DSP-100. This irregularity is caused by an instability of the DSP-100 MIC amplifier (IC-5).

Remove capacitor C200 from the IF unit on the transceiver, and replace it with R300, a chip jumper wire.

Replace with R300  
(R92-0670-05)
